## TECHNICAL BULLETIN #04082502

### X-RAY OF DETONATING CORD

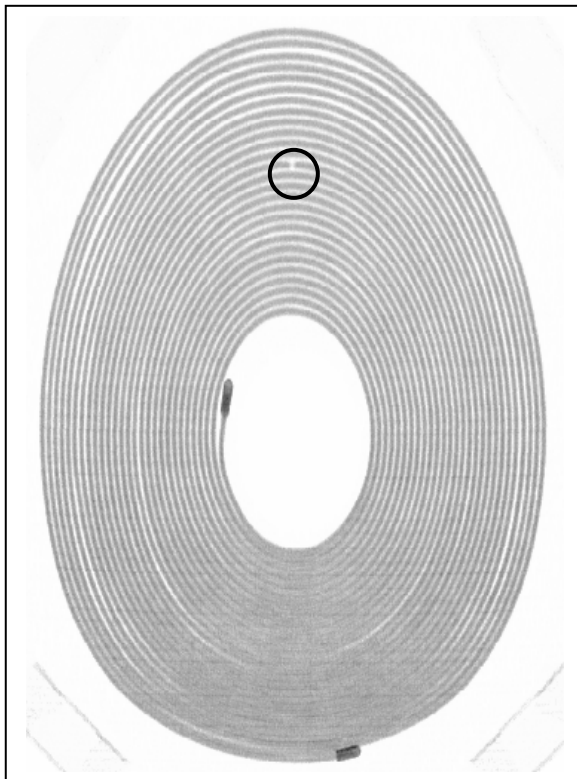
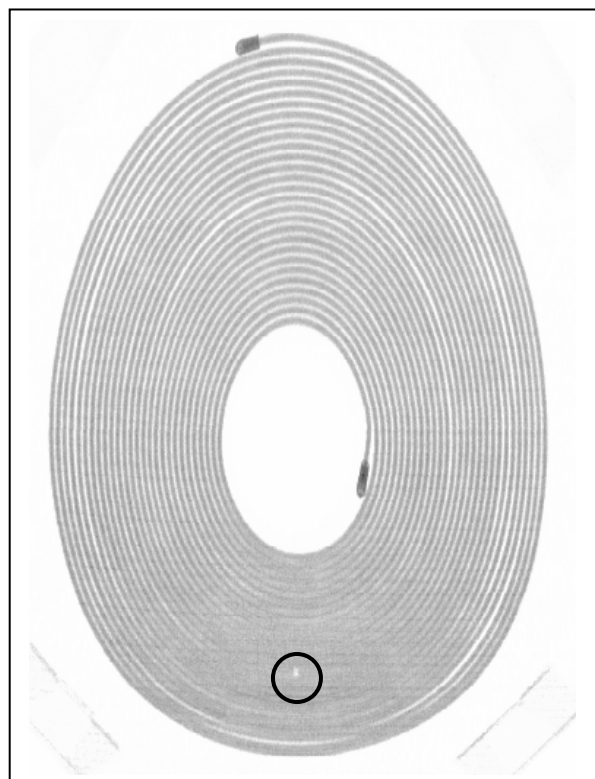
AS AN EXAMPLE THE X-RAY BELOW SHOWS A 3 MM (0,12") VOID IN THE EXPLOSIVES COLUM INSIDE THE DETONATING CORD. THIS 3 MM (0,012") VOID WOULD NOT CAUSE A MISFIRE (THE EXPLOSIVE TRANSFER WOULD RUN OVER THIS DISTANCE), NEVERTHELESS THIS PIECE WOULD BE REJECTED FOR SALE.

EACH COIL OF DETONATING CORD IS X-RAYED FROM TWO SIDES. THE EXAMPLE BELOW SHOWS THAT THE 3 MM (0,12") VOID IS EASILY DETECTABLE IN EACH CASE.

IN THE EFFORT TO ASIST OUR CUSTOMERS AND AS AN ADDITIONAL QUALITY CONTROL MEASURE **DYNAenergetics** OFFERS TO PERFORM A 100 % X-RAY CHECK OF ALL OF ITS DETONATING CORDS. THANKS TO THE NEWLY DEVELOPED 1.1D AND 1.4S **DYNAenergetics** DETONATING CORD PACKAGING METHOD (PLEASE SEE TECHNICAL BULLETIN #04082401) THIS IS POSSIBLE AT A LOW ADDITIONAL COST.
